Investigation of the NOAA N' Search and Rescue Antenna Inadvertent Deployment

Type C Mishap

**Final Report with Endorsements
and Final Approval by Appointing Official**

October 24, 2007

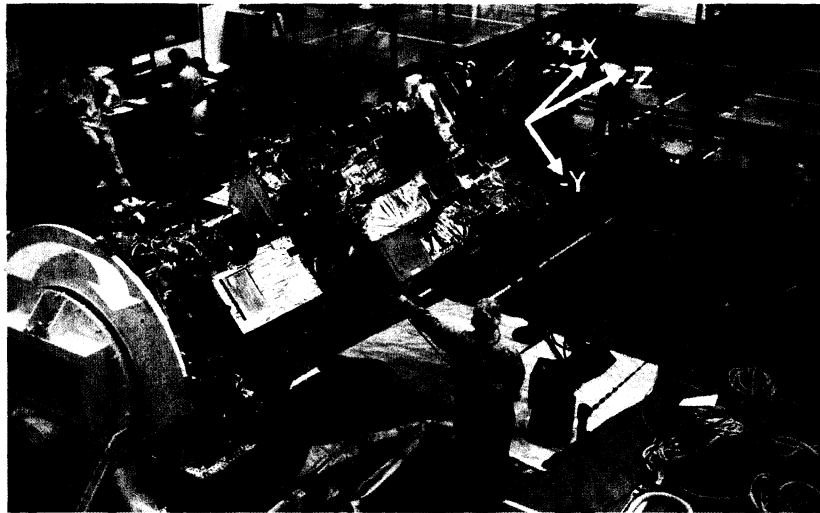
Figure 1

The NOAA-N Prime Search and Rescue Antenna (SRA) inadvertently deployed during a spacecraft rotation on April 14, 2007 (Figure 1). This rotation was part of a normal operation to configure the spacecraft for additional antenna and the solar array boom deployments. This procedure (red flag written) had been modified to look for a lost metal washer and a thermal blanket button. The flag to the procedure introduced a counter clockwise rotation before the normal clockwise rotation. The antenna was temporally stowed and held in place via lacing cord. The lacing cord broke and allowed the SRA to inadvertently deploy during the clockwise rotation. The SRA broke through a hard stop bracket and damaged an instrument optical sensor radiator panel. The satellite damage appeared to be minimal (Figures 2 and 3) and there were no injuries to personnel.

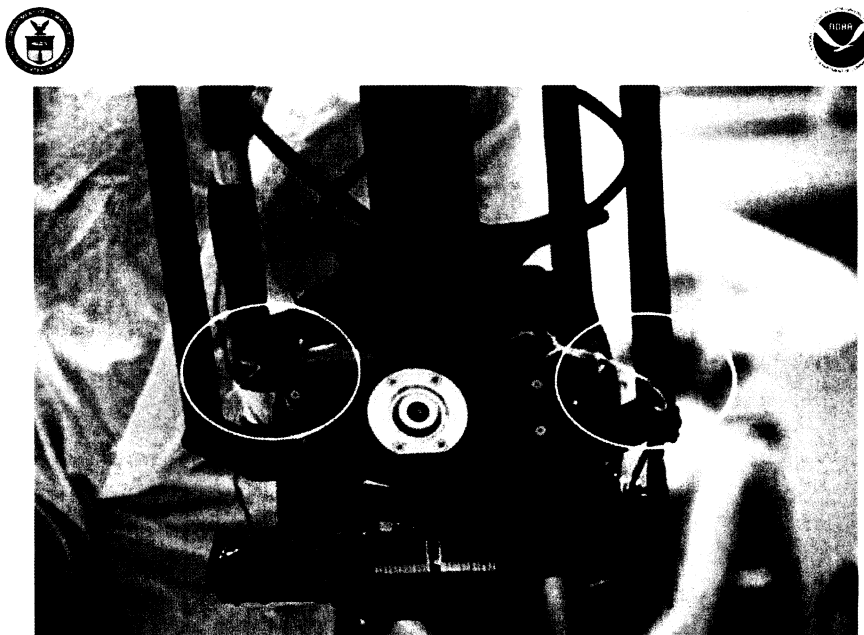
Figure 4

Proximate Cause (PC)- As tied (with a box knot), the lacing system used to temporarily stow the SRA, could not support the loads it was subjected to during the rotisserie/horizontal operation (Figure 4).

Contributing Factor 1 (CF1)- The tie procedure is non-specific and will not result in a consistent tie performance: no specific requirement of which lacing cord to use (3 sizes

were available for use), instructions of how to tie the lacing cord are vague and technician access is limited. Therefore the load capability of as-tied lacing cord restraint is not deterministic.

CF1A- Failure analysis showed the lacing cord used met its manufacturing specifications (Table 1) but that its strength was reduced by ~50% with the introduction of a box knot (Table 2).

CF1B- Structural analysis showed insufficient load-carrying capability of this lacing cord. Load carrying capability of this tie restraint system had never been analyzed prior to the mishap. Subsequent analysis predicts a tension load of up to 69 lbs, which exceeds the specified lacing cord strength of 50 lbs, and the nominal knotted strength of 28 lbs.

Recommendation 2 (R2)- If used, the load carrying capability of this tie approach should be conservatively assessed.

2A (R2A)- Perform FFMEAs and ensure conservative load carrying capability for this or any temporary stow approach includes appropriate factors of safety for a proposed operation.

Recommendation 4 (R4)- Make tie procedure more specific, review and update existing drawings and develop new as needed.
